# Refinery Solves Long Term Corrosion Problem By Deploying 3D TRASAR™ Technology For Crude Overhead Systems

## INTRODUCTION

A Gulf Coast refinery has experienced corrosion failures in the crude unit overhead exchangers for over 10 years, costing the refiner in excess of \$1 million per year in equipment, labor and lost production costs. The refinery plugs tubes, retubes exchangers and replaces exchangers as frequently as every 18 months. The biggest challenge the customer faces is trying to resolve this persistent corrosion problem is clearly identifying the contributing factors and directly linking these to unit performance and the exchanger failure rate.

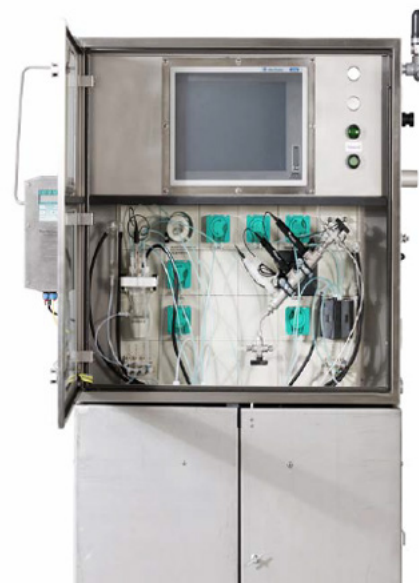
**FIGURE 1:** 3D TRASAR CRUDE OVERHEAD SYSTEM EQUIPMENT

To meet the customer's needs, Nalco Water deployed 3D TRASAR™ Technology for Crude Overhead Systems (COS). This technology uses a stream of crude unit overhead sour water to determine the corrosive state of this water in real time. Based on an analysis, the technology directly controls the addition of caustic, neutralizing amine and filming inhibitor to the crude unit overhead. The goal was to link the chemical addition directly to the demands of the overhead system. The technology was initially deployed on monitoring mode to observe the system and establish direct linkage between changes in operations and corrosion performance.

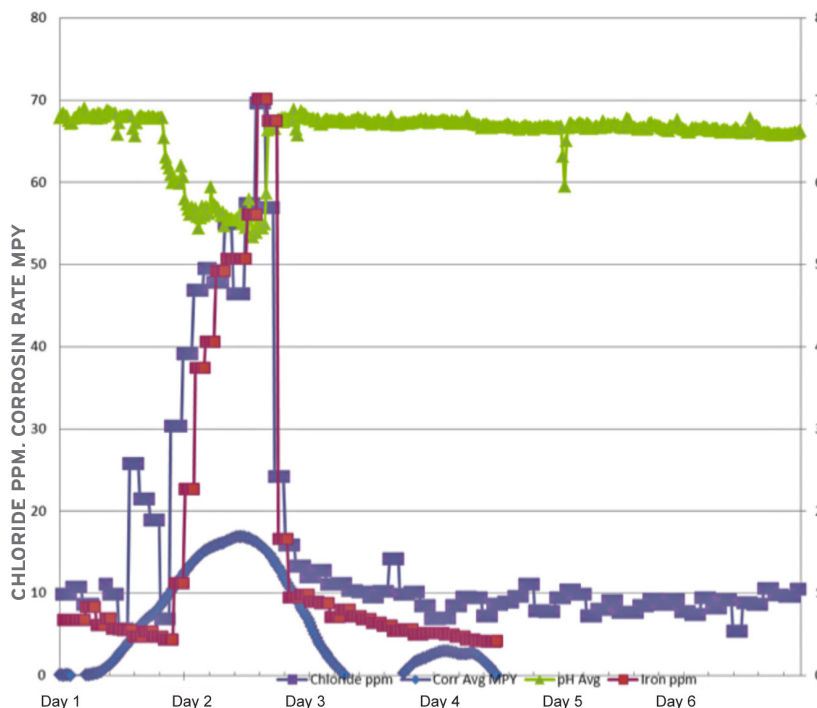
### CORROSION EXCURSION MONITORING

FIGURE 2: CORROSION EXCURSION DURING MONITOR MODE

The 3D TRASAR system discovered significant differences on corrosion rate measured by electrical resistance probes (10 mil/yr1) versus real corrosion rate measured by failure rate (40 mil/yr1). A decrease of pH and increasing chloride

and iron concentrations was observed during monitoring mode (Figure 2). As can be seen from Figure 2, considerable damage occurred during these periods of upset conditions.

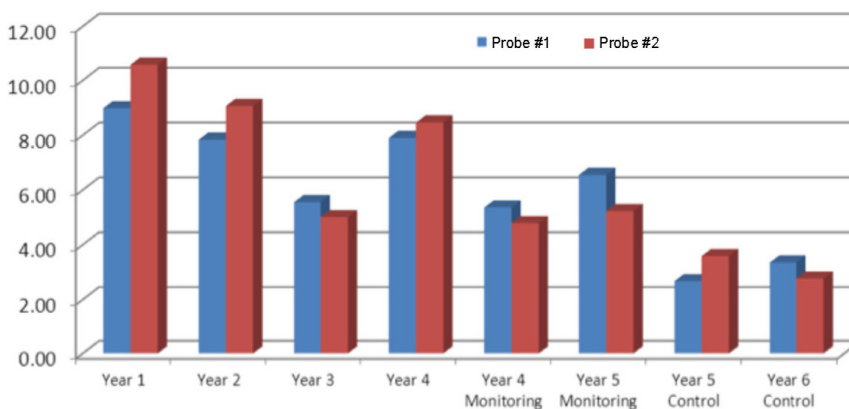
### CORROSION RATES MILS PER YEAR (MPY)

FIGURE 3: CORROSION RATES FOR BASELINE OPERATION, MONITORING MODE & CONTROL MODE

Once a firm link was established between upset conditions and changes to unit operations, the 3D TRASAR unit was placed into control mode. At this stage the technology was fully operational, providing real-time system monitoring and chemical injection dosage based on demands. Figure 3 shows how corrosion rates improved after year two, once chemical program dosage was based on real needs, versus a predetermined value. Corrosion had previously peaked in year one at 10.57 mils/yr., and prior to the implementation of the technology, year four at 8.46 mils/yr. With the advent of manual control, corrosion was reduced by 50% during monitoring mode and further reduced by 44% during control mode. In addition to the benefit of reduced corrosion and annual savings of approximately \$1 million, the refiner consumed substantially fewer chemical additives, to the tune of \$169,000 annually from year four onwards.
